Maniilaq Association
P.O. Box 256
Kotzebue, Alaska 99752
(907)442-7639

Report Date: August 28, 2009

Subject: Buckland Brownfield Inventory visit 5/26/2009.

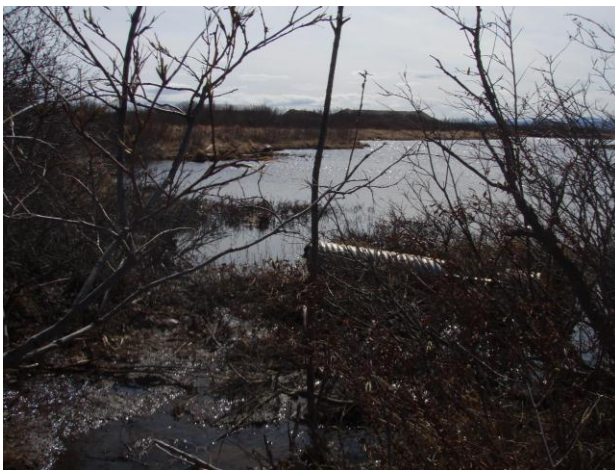
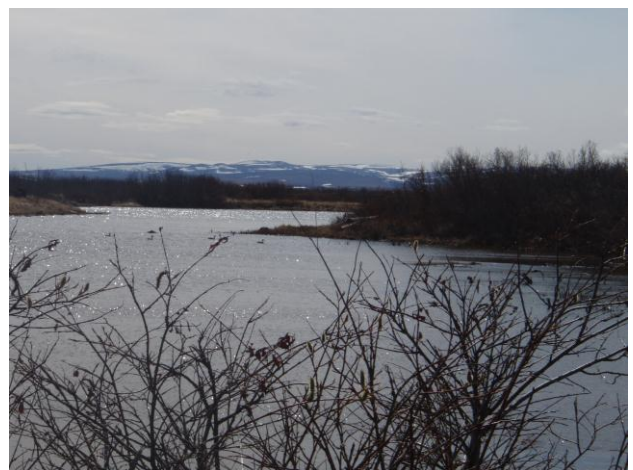
1. **Early 1960's Dumpsite on Tundra Pond Banks-** Located Track II Parcel A on site map, pond/lake with connecting creek lies between terminal end of airstrip and due west of north end of town and only limited access from the airport road. The pond is several acres in size with overflow drainage via roadway culvert and creek to nearby Buckland River 200 yards (approx.) distance. Previous use as dumpsite evidenced by what appears to be old generator components, 55 gal. drums, snow machine frames, water/sewer carrier pipe and other unidentified rusting materials. Mentioned items are located both in and out of water with some only partly exposed. Residents are concerned about environmental contamination of water and habitat (fish and mammal) from petroleum and rusting metal debris. They "would like to restore the creek and be able to fish again"
Redevelopment Reuse Purpose...Return to green space.

Exposed drums and water sewer carrier pipe, snow machine parts

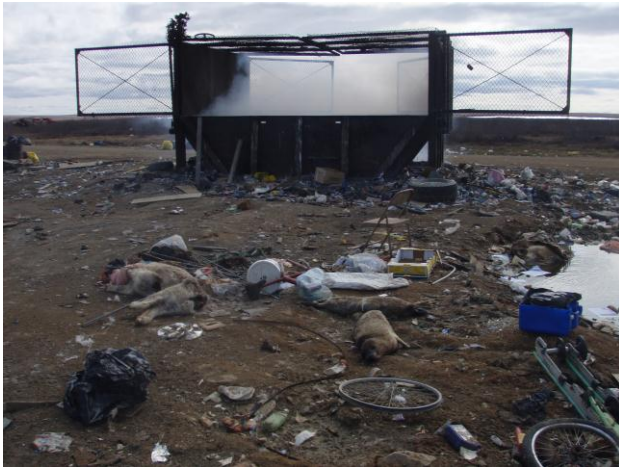
2. **Buckland Class III Landfill (opened 1986); Status: Active-** City owned/operated landfill located required minimum distance at least from airstrip and community and lies due west from town center. The dump is constructed on grade of earthen berm type containment with fencing on top and gated single entrance. Fence in moderate disrepair with barbed wire retainer top of fence also compromised in sections. The entrance gate was open, appeared broken, nonfunctional. The dump is mostly self-haul with unrestricted access to public all hours, site control signage for improved dump management, nonexistent. **General condition of dump is as follows:** Garbage and cover material compaction not being done (Note; suitable cover material available and stockpiled onsite), ponding of water/leachate allowed at entrance and inside dump deters residents from entering, result; dump outside fence (see photos). “Summit Const.” type burn box observed with gates left open-smoldering-unattended, variety animal carcasses left on ground outside dump or mixed in with misc. non-segregated refuse. Additionally, numerous 55 gal. drums loosely staged at entrance, contents unknown, some with bloated tops and standing in “water” with petroleum sheen, runoff potential exists to nearby ditch ultimately to creek some 60 ft. behind landfill. **Overall description based upon observations made this date: Poorly Maintained.** Residents understand environmental and health impact when household refuse, animal and human waste left exposed along with leachate and petroleum contamination of surrounding water bodies/groundwater, etc...**Reason for citizen concern?-** “Landfill leachate flowing thru creek behind the landfill where we used to trap for fish!” Redevelopment-Reuse- Purpose; undetermined.

Burn-box and animal carcasses

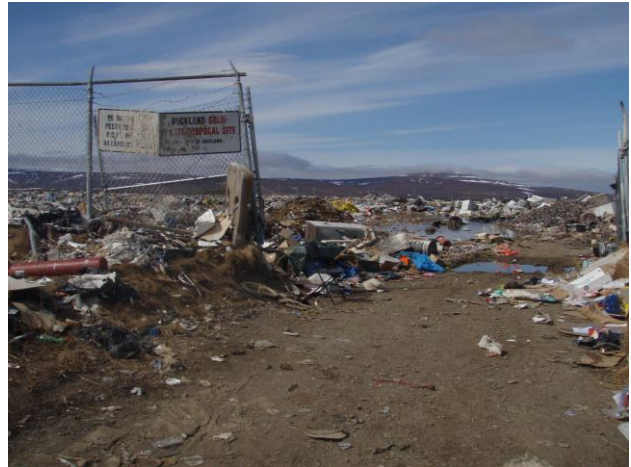
Dump entrance with ponded water

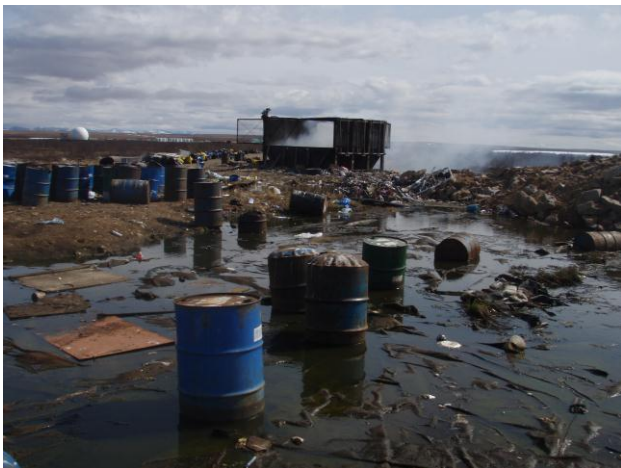
Misc. drums in water/leachate

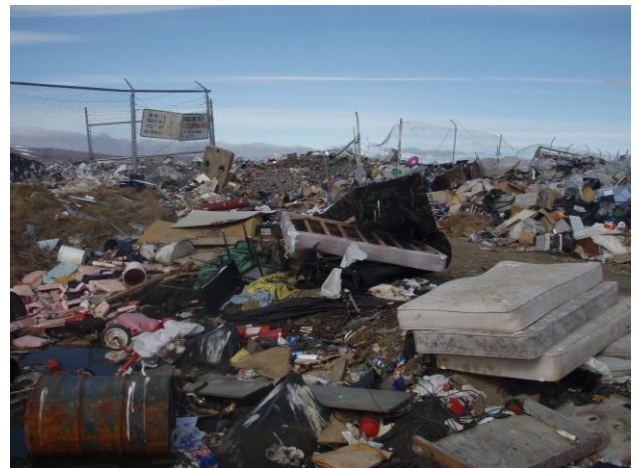
Non-Segregated refuse at entrance

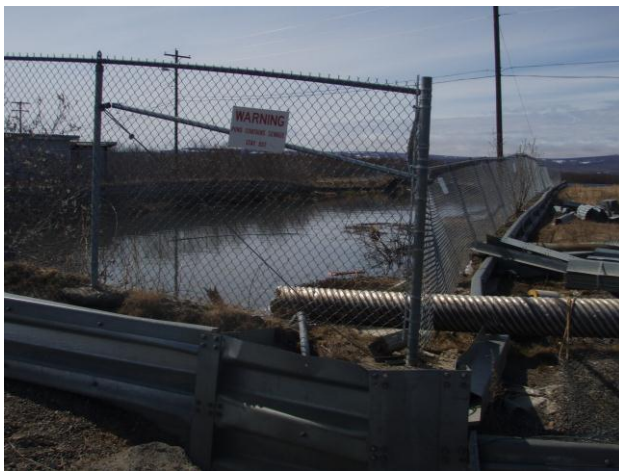
3. **Washeteria/School Waste Water Lagoon (Active)** - Map identification; Public Utilities Easement Parcel B Block 3 and located “between uptown and downtown” centers receives untreated sewage discharge from the subject locations; this discharge likely to contain raw sewage, laundry detergents, and cleaning type chemicals. The lagoon is rectangular in shape estimated size to be about one acre, containment constructed of shallow earthen dike and corrugated metal bulkheads or railings topped with chain link security fencing (Note: fence unstable due to soil erosion at post bottoms, needs repair). Adequate site control signage is clearly visible, warning of lagoon contents. Discharge to lagoon is through insulated carrier pipe elevated some two to three ft. above water surface, freefalls into containment. This discharge point is located NE corner just inside fencing some 200 ft. from washeteria. Primary concern to residents is “during flood time in May the water rises from the back of the village from two mile lake and goes through all parts of the village including the Old Dumpsite on Airport Road, the current landfill, and the sewage lagoon overflows out to the river, when the water level starts to go down” leaving undesirable residue in wake. Community Redevelopment Plan; limited plan includes “keeping lagoon open until (new) water/sewer system is completed and would like to get this (one) cleaned up if it is not going to be in any use for future” waste water management, then could be redeveloped for green space.

Lagoon w/discharge pipe and warning sign

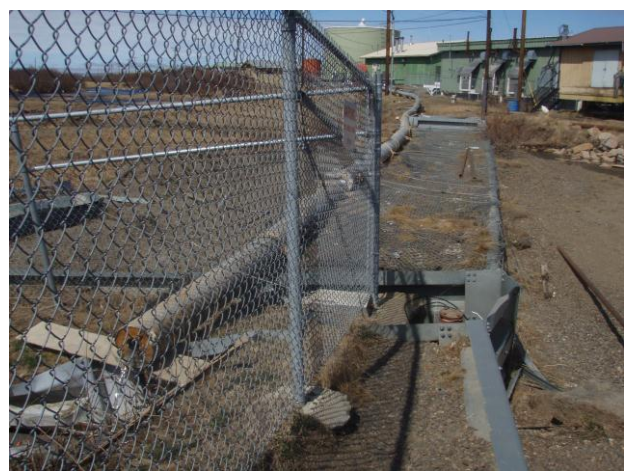
Water plant, washeteria and pipe to lagoon

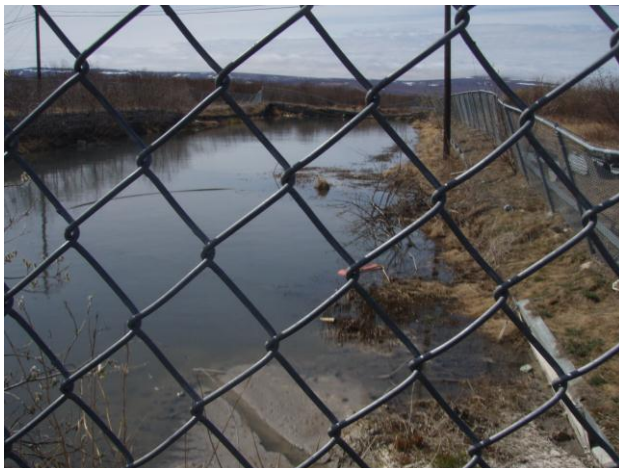
Lagoon view through fence

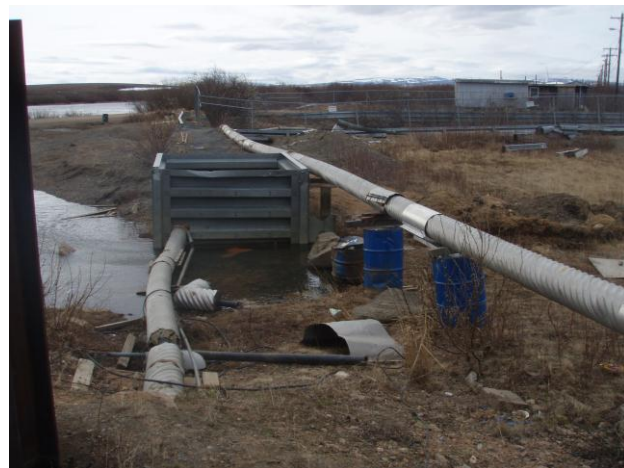
Waste water discharge to lagoon (top pipe),
City water source line from river (lower pipe) to water treatment plant

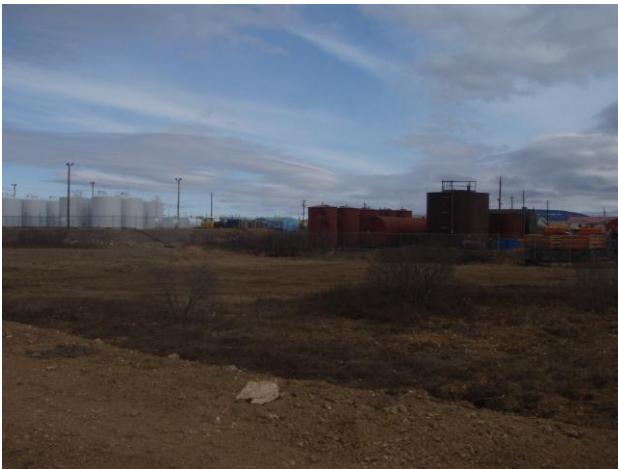
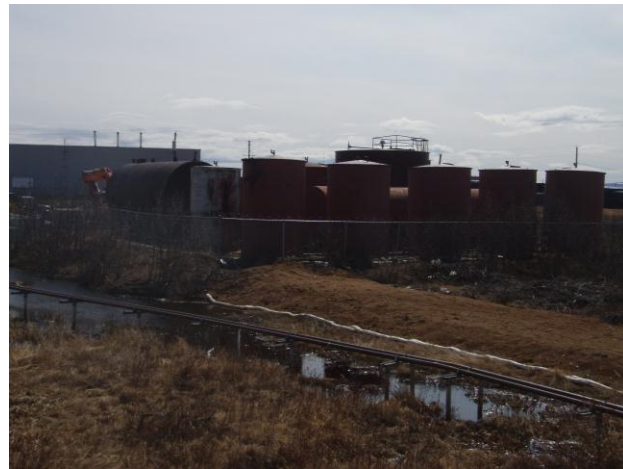
5. **Fuel Tank Farm (New) Status; Active-** Located adjacent to “homes, very close to the lakes that drain into the river where we fish and hunt for marine mammals” described as new tank farm; is actually fairly old and intended to supplement fuel storage needs until new bulk_fuel storage facility completed and is apparently still used to some capacity. Local source historical knowledge informs “this was an old tank farm and built to add on the new tank farm in your 2003. This last year 2008 there was a spill of about 8,000 gallons. There was a crack in the holding tank”. Continues on to describe clean up attempts sad “they got tanks and tanks of snow and stove oil, burned them in ash burner” along with 2-3 ft. depth excavated contaminated soil “burned them too”! Response to the Redevelopment-Reuse Question; “the stove oil, is it cleaned up well?” “Would like to clean it up and make sure all stove oil is cleaned-up” the answer.

New Bulk fuel Storage adjacent to Old-New tank farm and drainage ditch

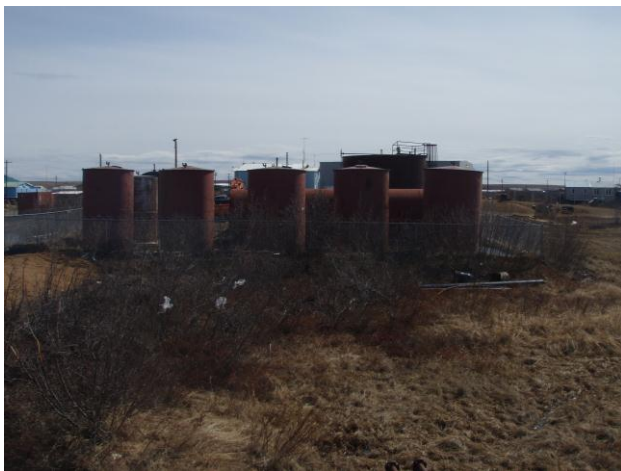
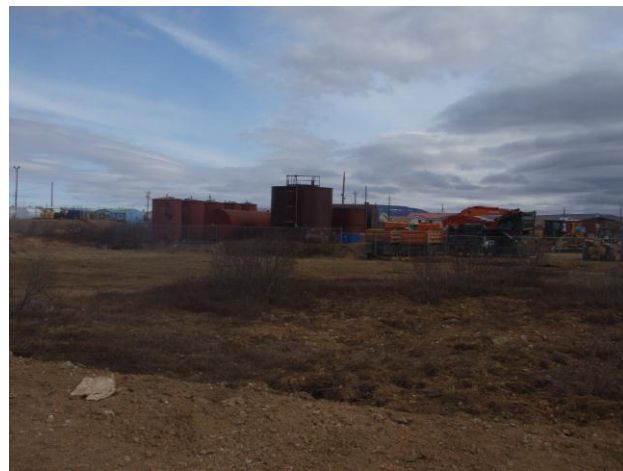
Tank Farm and proximity to homes, and equipment storage
