Maniilaq Association
P.O. Box 256
Kotzebue, Alaska 99752
(907) 442-7639

Report Date: August 31, 2009

Subject: Kobuk Brownfield Inventory Visit; 5/29/09.

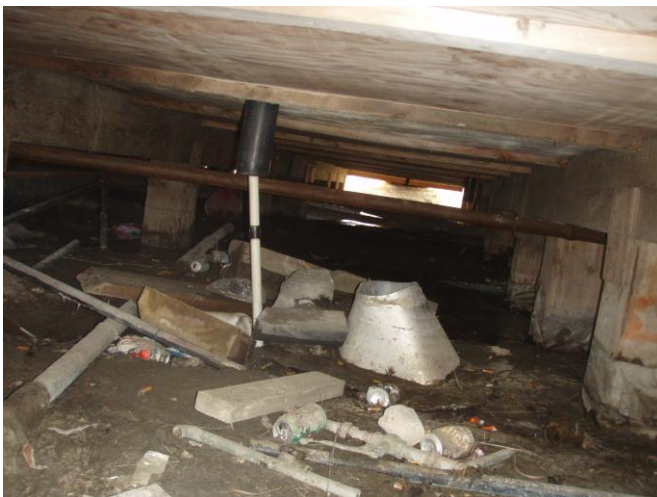
1. **Washeteria/Water Treatment Plant (WTP)**- Located same building, washeteria no longer operational however WTP is active. Problem exists due to impeded treatment plant fuel delivery system requiring operators to transfer facility equipment fuel via hand pump from 55 gal. drum to “day storage” tank inside bldg. Inadvertent spillage finds floor drain then ground below, within 10 ft.(approx.) of City Water Source Well. Examination of vertical drain under WTP evidenced no significant petroleum contamination, however discovered a 1 in. dia. PVC drain tube terminating in a bleach jug receptacle. Presently this condition has changed; floor drain has been satisfactorily modified and informed by Maniilaq Environmental Health Mgr. drain is sealed from inside as well. Fuel delivery system not repaired to my knowledge. Environmental Coordinator took exceptional measures including notifying Administrator City of Kobuk, DEC, Maniilaq Environmental/Health Program and fixing floor drain, Carl says “just need to protect the drinking water well”.

Floor Drain Pipe to Ground

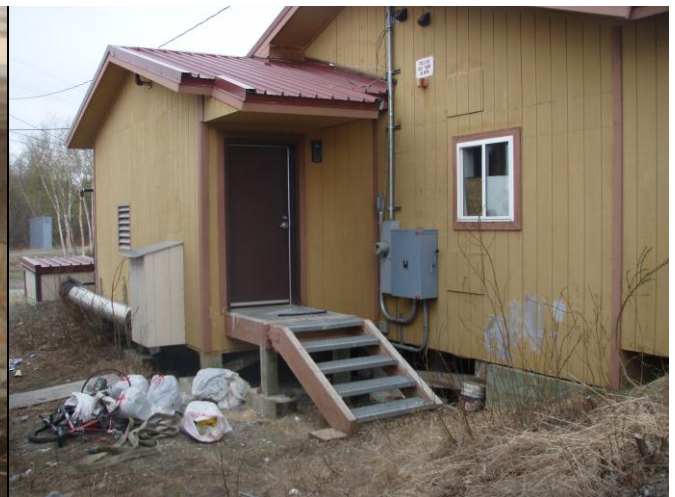
WTP, Source Well under bldg. one ft. from steps.

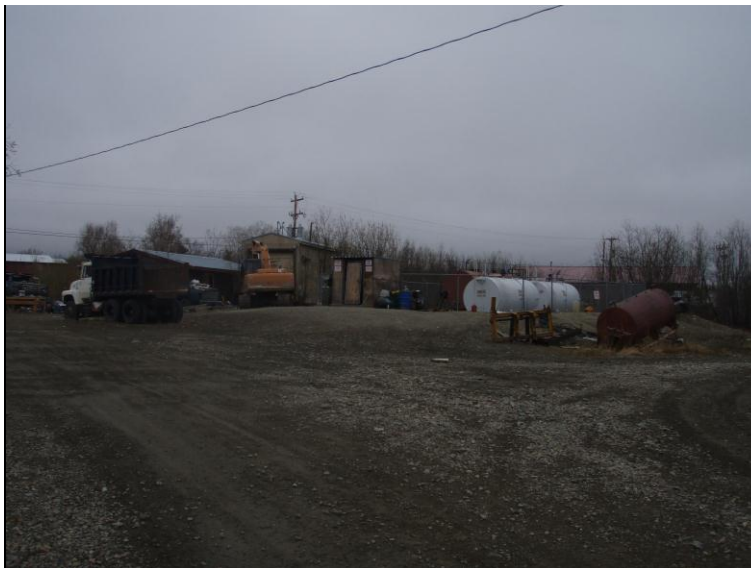
2. **Old Fuel Farm Site/Search and Rescue Shop (Combined Locations)-** Side by side these show evidence environmental contamination, years of routine sloppy petroleum handling practices, transfer and storage, resulting in product stained soils in and around tank farm and shop bldg., abandoned dump truck front of S&R shop leaking oil to ground underneath. Also problem exists with used oil accumulating and becoming contaminated w/ antifreeze, water etc. creating waste oil condition and a potential HAZMAT situation. To date used oil is stored reasonably well and looking at methods of utilization within community; oil fired heaters, blending with diesel for heavy equipment use.

Search and Rescue Shop/ Old Fuel Tank Farm and Abandoned Dump Truck

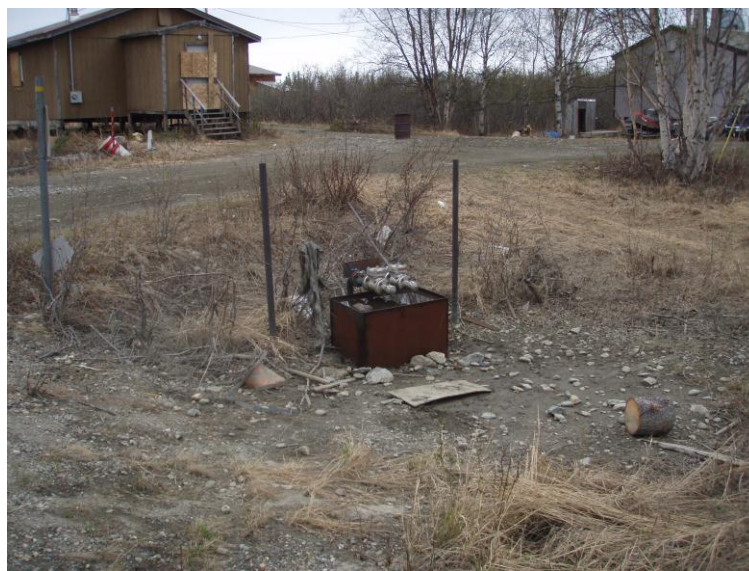
3. **Bulk Fuel Delivery Transfer Site-** Located proximity airport equipment storage bldg., homes and Friends church entrance. Transfer site consists of two, 3 in.dia. (approx.) coupling type connections with valves. Spill containment provided by steel open top box approximately three cubic feet volume underneath valve arrangement. Concern arises due to catchment filled with large rocks and of course is full of water, then due to spillage or fuel loss during years of transfer operations overflows to surrounding ground. There appeared no drain to remove contents. Redevelopment reuse plan, undetermined.

Bulk Fuel Delivery Transfer Site near Homes and Airport
