Maniilaq Association  
P.O. Box 256  
Kotzebue, Alaska 99752  
(907)442-7639

September 5, 2009

Submitted by: Stanley Tomaszewski; Brownfield Coordinator

Subject: Shungnak Brownfield Inventory visit 9/01/09.

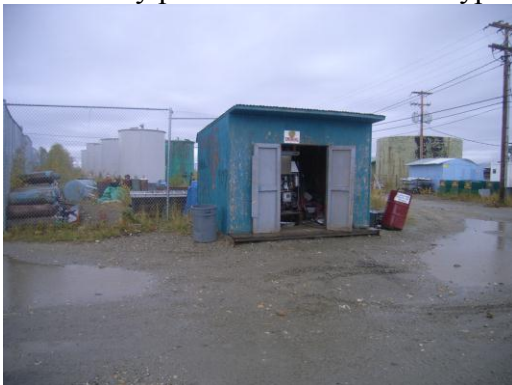
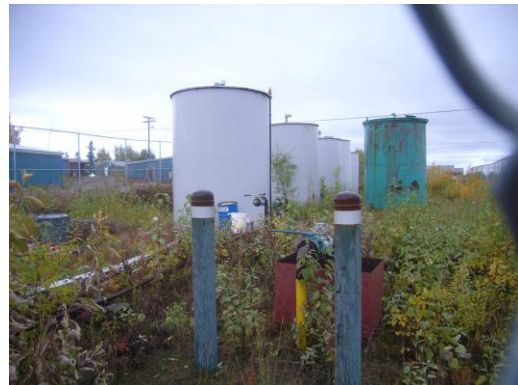
Shungnak Native Store Tank Farm and Gas Pump House

1. **Shungnak Native Store Bulk Fuel Tank Farm (Active)-** Tank farm was constructed sometime during the “mid-70’s” and consists of eleven steel, single wall constructed storage tanks of 5,000 gl. (approx.) volume each, with adequate bolstering. This tank farm for bulk storage gasoline and stove oil is located mid-town next to the Native Store and separated by side road (Note- side road contains phone/power pole easement middle of road!) from AVEC power plant and support bulk fuel storage tanks, Water Treatment Plant and storage tank 200 ft. distance. Homes are located front and rear of facility only separated by unpaved road. Tank farm is fenced with security gate and earthen berm containment, liner not observed. Fuel dispensing for gasoline sales via typical metered pump housed in small plywood shed located, outside fence enclosure, off frontage roadway, no provision for spill containment. Recent persistent rains and water saturated soil obscured any visible indication of possible petroleum contamination thereon. **Residents concern regarding environmental and related health risks include** “Benzene emissions blowing into residences, residents breathing it in. Too close to town and concerned about children’s safety and **FIRE HAZARD**”. Additionally, a “small spill reported (40 gl. est.) and clean up was done, after former IGAP reported to DEC, maybe in “2000”, cleanup measures not revealed, residents submit being able to “still smell (gasoline or stove oil?) in the spring.” Prevailing wind direction and proximity to power generation facility **exhaust fumes**, made difficult detection smell of gasoline or “stove oil”, none was noted this day. Regarding phone/power pole easement location, understand vehicle impacted one pole causing it to loosen/tilt, subsequent repair (not to vehicle) exposed “petroleum at base of pole”. Further, James reports some long time and elder residents of homes “nearest to tank farm suffer from chronic arthritis type symptoms and even stroke(s)”. Local historical information suggests prior to current use served as “a trail to get to the old airport.” Possible redevelopment plans include “community picnic area” and some type of “ball court”.

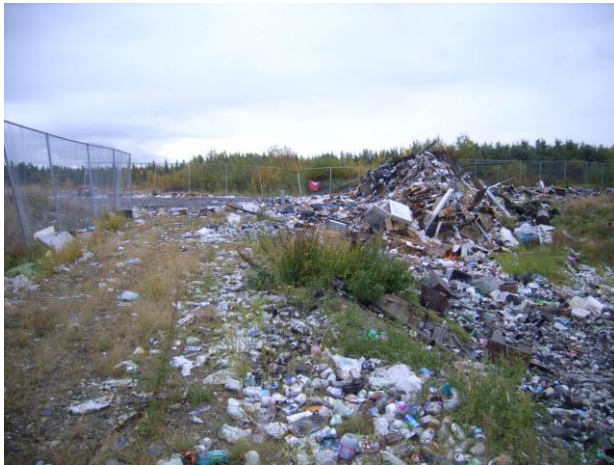
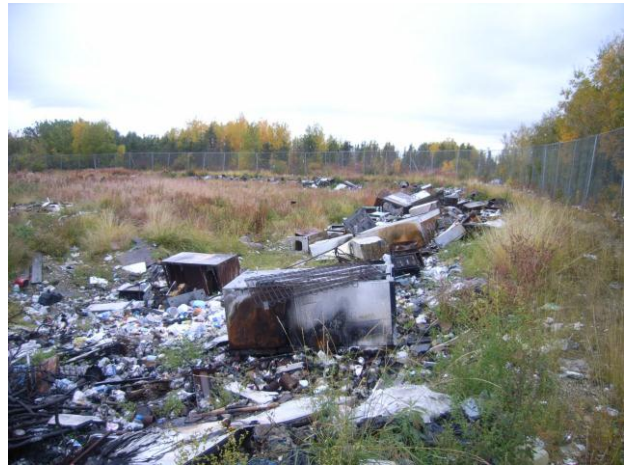
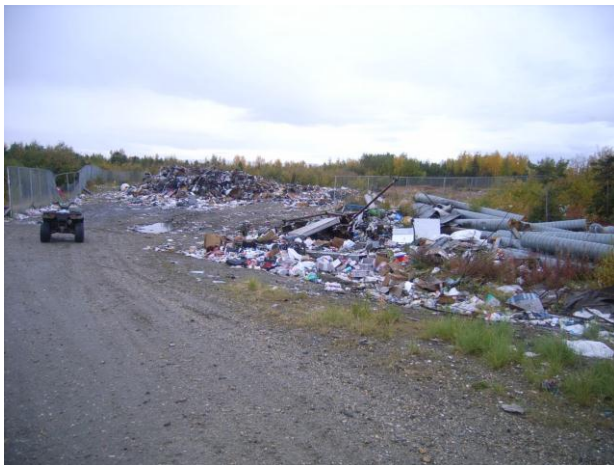
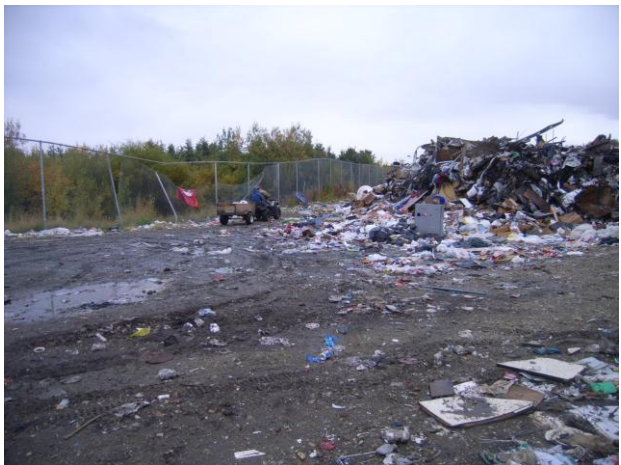
Shungnak Landfill

2. **Shungnak Landfill (Active)**- Constructed mid 70's and located approx. one half mile due south of airport equipment bldg. and one mile (est.) south west of community. This "dump" is "within 1,000 ft., or so, of cemetery and a Native allotment" which requires residents travel past the dump whenever visiting graves site. Understand that preliminary planning for new landfill location has it sited some "2.2-2.4 miles north of town" placing it within permitting requirements for distances from airports and communities, other stuff. **Presently**- active dump is self-haul; site access is unrestricted all hours of the day or week with perimeter fencing three sides only leaving a wide-open entrance (no gate). This condition allows prevailing wind blow debris across road collecting in vegetation that side. Further, site controls any form are non-existent and overall maintenance condition is poor. Refuse not being pushed to back of dump where plenty space remains available, garbage not being compacted/covered allowing (huge) pileup completely restricting entrance thereby creating the mess in front, vectors. No burn box or equivalent on site and is evidence of open burning on ground which creates fire hazard to heavily vegetated site location (trees). James informs heavy equipment (bulldozer) sometimes available for dump maintenance "has damaged gearbox limiting forward speed to a creep taking half a day to get to dump" ...concern of vandalism precludes leaving dozer unattended "operator would have to camp out at dump", not happening. Time frame for new dump construction "best estimate...four to five years". Redevelopment-Reuse- ?
