Maniilaq Association  
P.O. Box 256  
Kotzebue, Alaska 99752  
(907)442-7639

**Report Date:** August 27, 2009

**Subject:** Noorvik Brownfield Inventory visit 8/25/09.

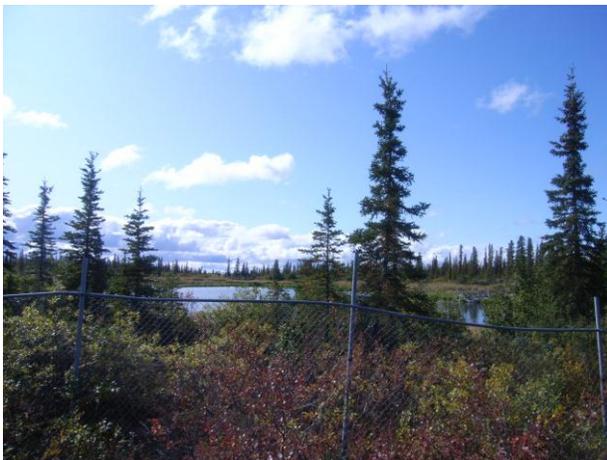
1. Active Sewage Lagoon (Untreated)- Several acres in size located approx. 1/8 mi. due East of community and equal distance from old airstrip to the West. Appears to be tundra pond natural depression without containment and is surrounded completely by tundra and spruce mixed. Very difficult approach to fenced perimeter (not well maintained) with warning signage of contents and no access to inside of fence found this visit. Was able to observe at distance substantial free flow from carrier pipe several feet above water surface visible in figure 1 lower right. Lagoon is at elevation above tundra ponds to SW and connected by natural drainage path through to road culvert. After freeze-up sewage discharge into lagoon tends to flow over and under ice to lower elevations findings way to proximity residential area and eventually to the river.

**Sewage Lagoon**

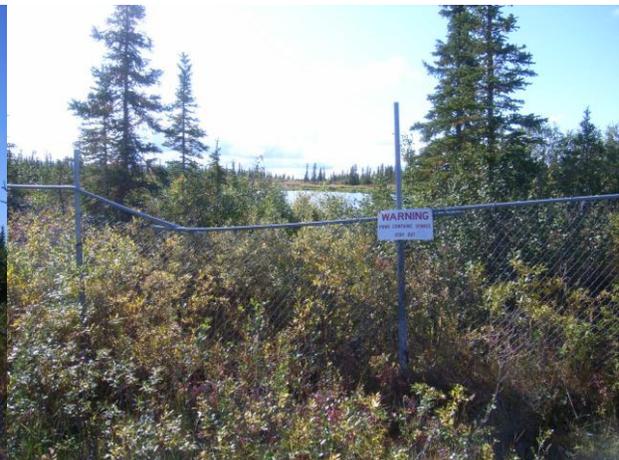
**Warning Signage**

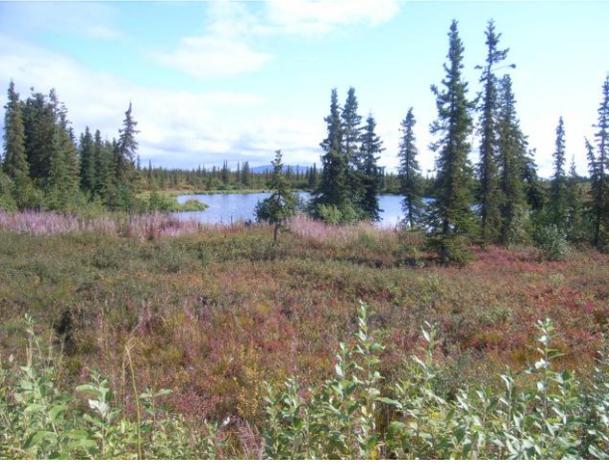
Lower Elevation Tundra Pond

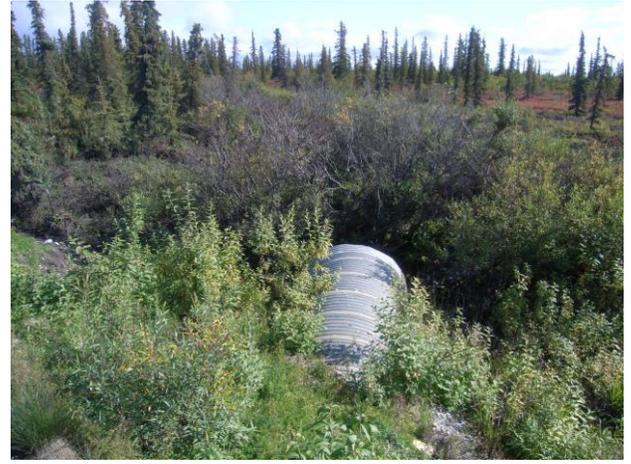
Roadway Culvert

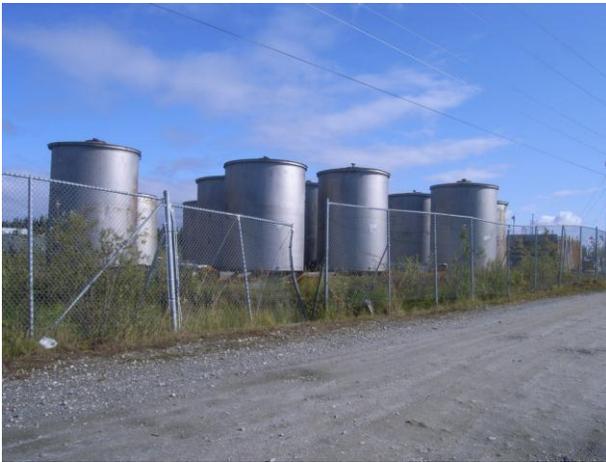
2. Old Bulk Fuel Storage Tanks (AVEC)- Located on the edge of town between old and new sewage lagoons directly next to active power plant and new bulk fuel storage. Containment for old tanks via perimeter ditch and security fencing in disrepair as is tank bolstering. Status: Abandoned.

**Figure 3 Old Tank Farm**

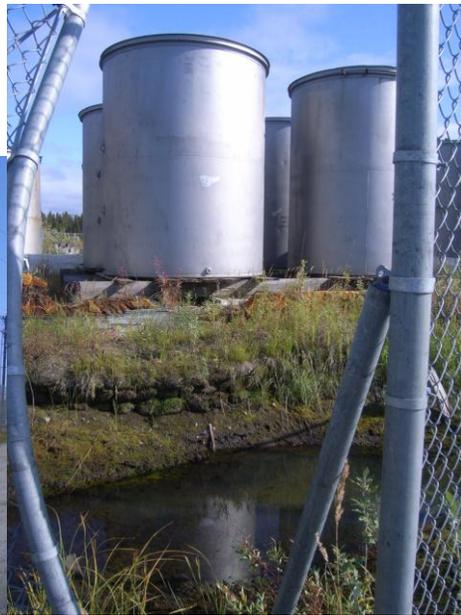
**Figure 4 Containment**

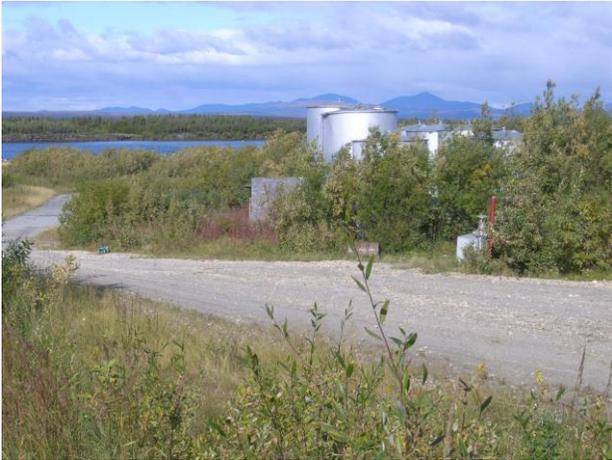
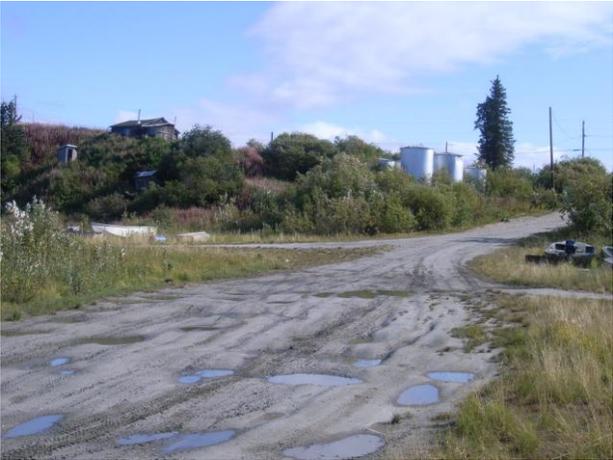
**3. Noorvik Native Store Bulk Fuel Tanks (Abandoned)- Located on beach side of town and consists of two groups of tanks separated approx. 200 yards same distance to river, swimming, other recreation, subsistence fishing. Tank farm was used many years, signs possible petroleum contamination.**

**Native Store Fuel Tanks (Abandoned) Note proximity to Kobuk River**

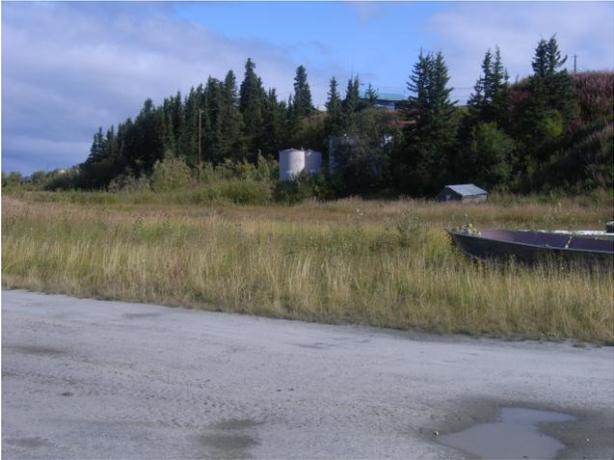
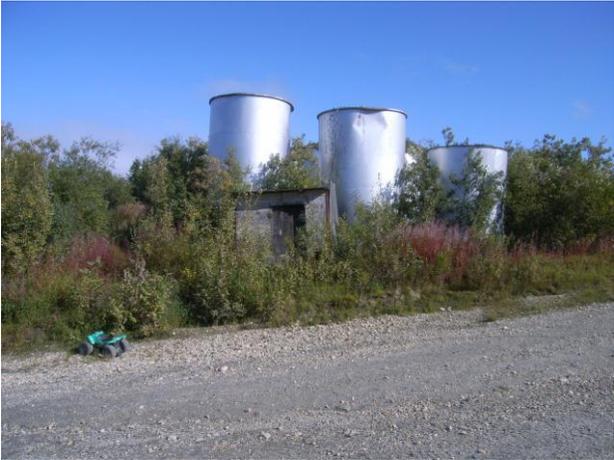
**Native Store Fuel Tanks two locations approximately 200 yards apart, no longer used.**

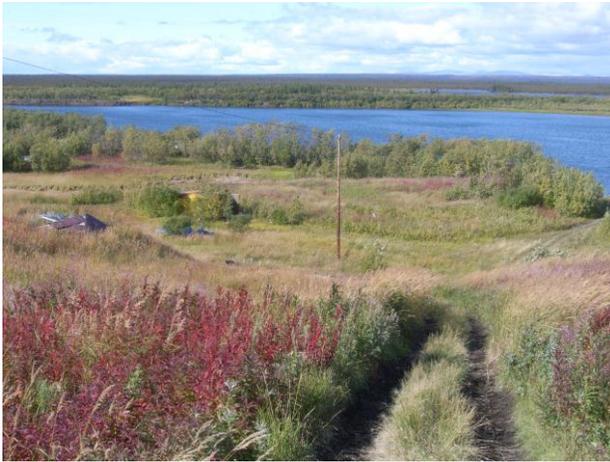
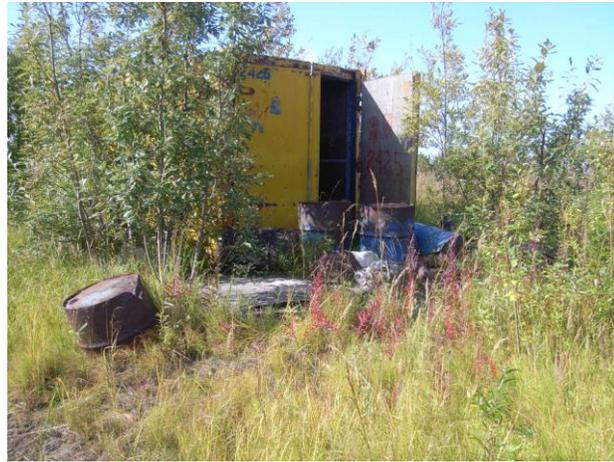
4. Morris Trading Post Tanks and Storage- Located on beach side of town, north end, approximately 100 yards from river bend, local swimming and fishing, previously used to sell dispense stove oil and gasoline now abandoned. Presently bulk tanks consist of 55 gal. steel drums and a old gas metering pump noted at site along with storage connex. No containment for material storage evident, site is overgrown with vegetation. Trading Post was in operation for years, possibility of petroleum contamination exists.

**Former Morris Trading Post, 55 gal. drums adjacent to storage connex, contents undetermined.**

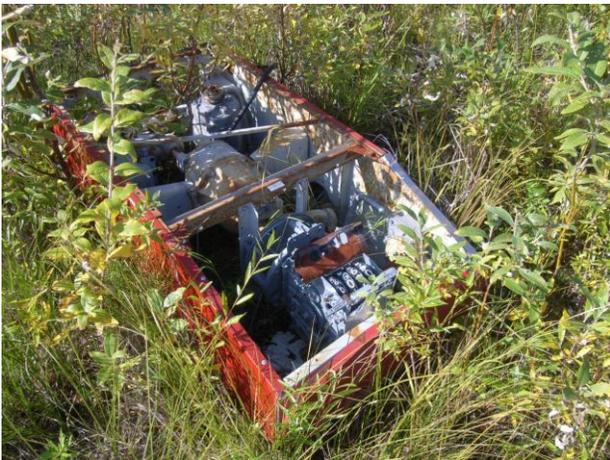
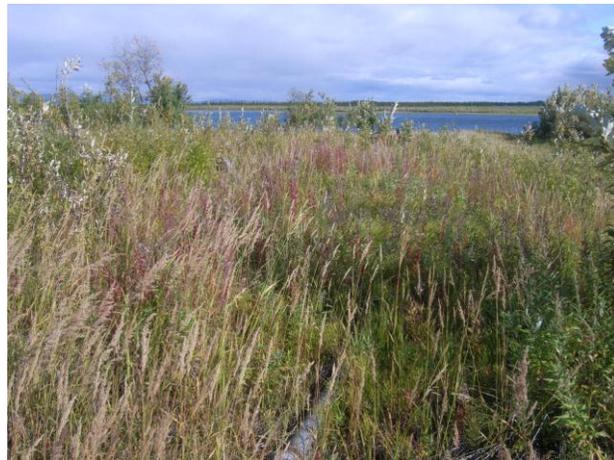
**Petroleum metering pump and mounded earth “pad” covered with vegetation. Pad possibly used for elevated tank support.**

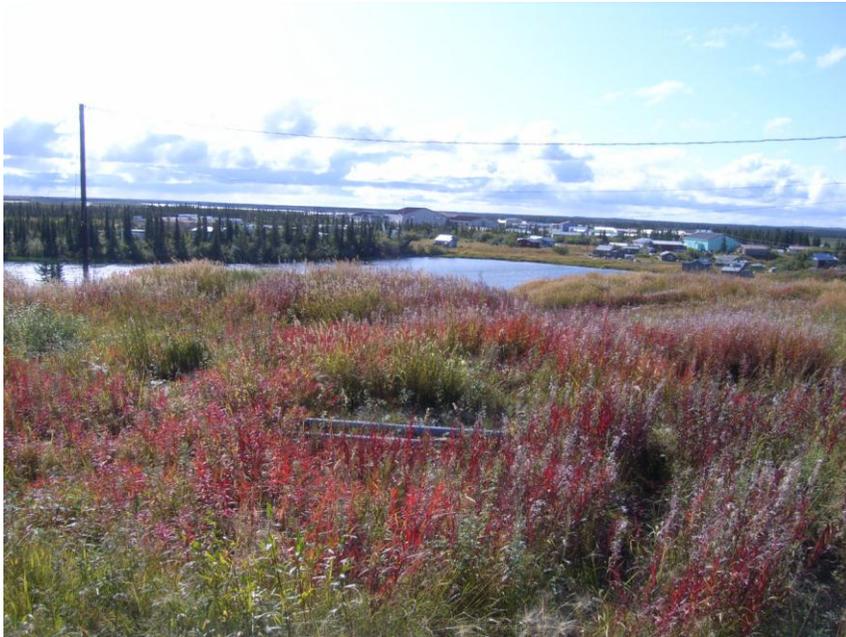
5. Old Sewage Lagoon (Municipal Reserve on map) - Several acres in size, located north end of town. Local historical information suggests used as primary sewage lagoon for 40 plus years is no longer used for that purpose. Residents inform still smells of previous use and tend to flood banks in spring draining through town into river and city water source intake area putting at risk community drinking water quality.

Inactive Sewage Lagoon viewed from elevation looking south.  
Note nearby homes.
