Maniilaq Association P.O. Box 256 Kotzebue, Alaska 99752

August 5, 2009

SELAWIK BROWNFIELD VISIT:

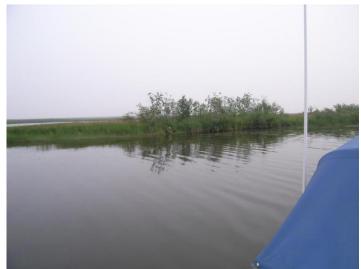
An old DC-6 cargo plane which is under water in the Selawik River, which according to the local IRA Council, has been sunken for at least 20 years. The local concerns includes leaching of the contents of cargo plane which is possibly diesel fuel, haphazard conditions for river boats, and the fact that a body, which perished one fishing season, got lodged at the bottom of the plane and couldn't be retrieved until a searcher hooked it during a search.

Site of the old abandoned DC-6 plane sunken under Selawik River

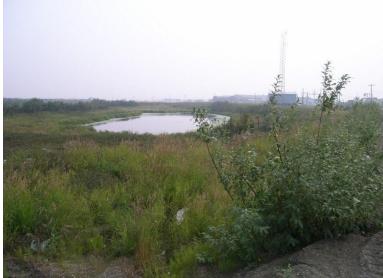
The old dumpsite down river was built in the 1970's. It should no longer have been used, but people without a snow machine and/or ATV uses their boat to dump their solid waste. Within the proximity

of the old dumpsite are two fish camps, one belonging to an elder widow, and the other, to a local Elders' camp. The widow still harvests fish out of the river near her fish camp. The city owned the old dumpsite and the old sewage lagoon. The sewage lagoon is located across the new AVEC tank farms, behind the school. The old sewage lagoon is about 50 yards from the river which flows to the widow's fish camp. The old sewage lagoon is also near the school's play ground.

Selawik Abandoned Sewage Lagoon near the school playground and within 50 yds of the Selawik River.

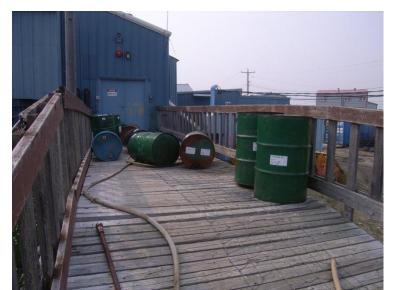
There are approximately 20 abandoned 55 gallon tanks that contained Dowfrost 4060 chemical. They are within 100 feet from the school building.

Selawik Abandoned 55 gallons drums on the Washeteria porch, more are around the building.

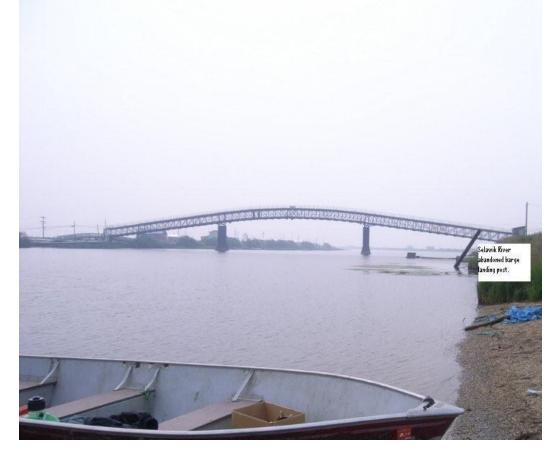
When the bridges were being built, there was huge metal post lodged in the river banks to hold the barges that hauled in the bridge material. The metal barge posts are now rusting and falling into the river. The city, nor any of the barges, uses this metal barge post anymore. The barges don't come that far into the river.

Abandoned Metal Barge Post in Selawik River
